NASA Unmanned Flight Anomaly Report:

INVESTIGATION OF MECHANICAL ANOMALIES AFFECTING INTERPLANETARY SPACECRAFT

David Oberhettinger

September 1994

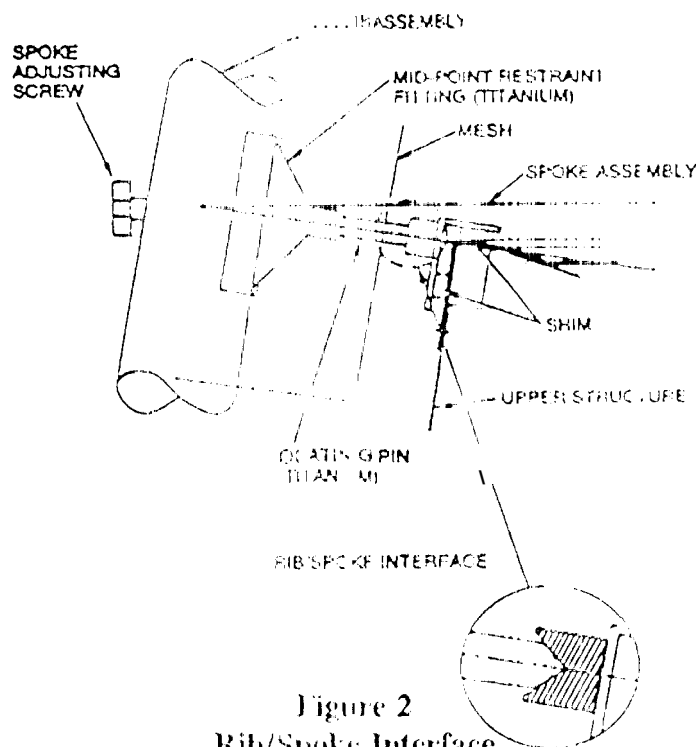
The failure of these efforts led analysts to believe that several stink ribs were restrained at the pin and socket fittings, provided at the midpoint of the antenna ribs to prevent flexing during launch. This midpoint restraint features two pins with spherical ends reacting against an 85 lb. preload on the spoke. One pin engages a conical socket and the other a V-groove socket. This V-groove was a JPL innovation; both sockets on the original TDRS design were conical. Figure 2 illustrates the location of the fitting within the rib-spoke interface.

After a two-year investigation at JPL, the failure mechanism was isolated to friction in the midpoint restraint pin/socket interface. Preloading of the ribs when stowed at the factory

damaged the V-groove pin ceramic coating, which served as the bonding surface for the dry lubricant. Accumulated stresses from vibration testing, rib preloading, four cross-country trips, and post-launch ignition of the UPPC stage further dispersed the lubricant film. Due to the resulting friction, some ribs required more force than the drive motors could generate, causing asymmetrical deployment and restraining forces which further reduced the torque available from the drive system. Workarounds using an IGA, new data compression techniques, and the spacecraft's recorder are expected to meet 90 percent of the mission objectives.
